Final Report  
**SEPTIMA CLARK  
PEDESTRIAN  
BRIDGE  
FEASIBILITY  
STUDY**

**Berkeley-Charleston-Dorchester  
Council of Governments**  
*at the request of SCDOT*

January 2015

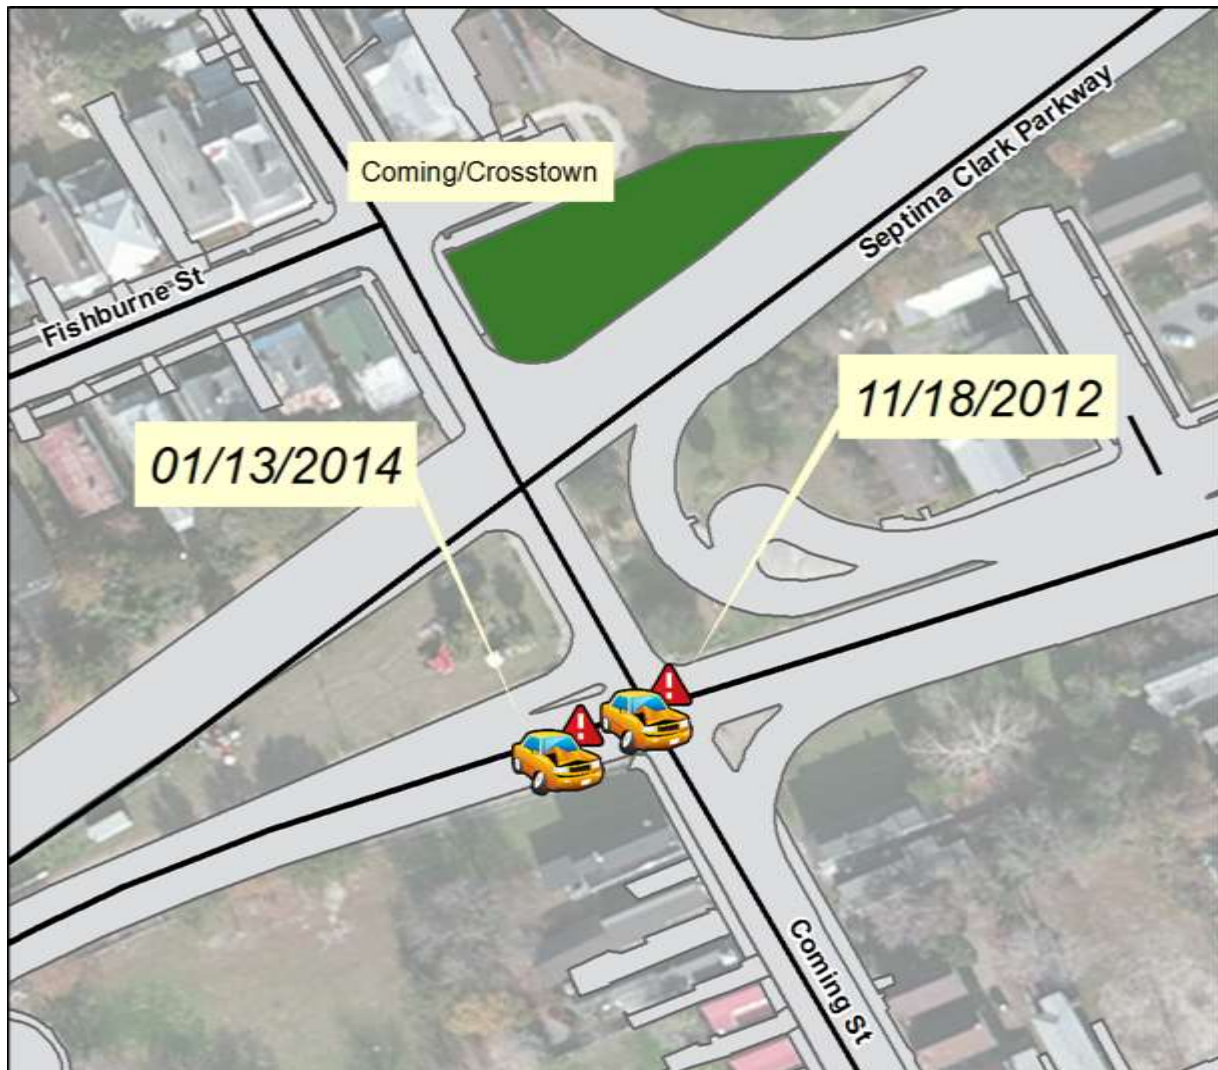
Figure 9 – Fatal Accident Locations

On November 18, 2012 at approximately 2:25 a.m., a motor vehicle heading northbound on US 17 at the intersection of Coming Street struck two pedestrians attempting to cross the intersection. The two pedestrians were leaving a party on Sumter Street, crossing Septima Clark Parkway eastbound on Coming Street to return to their dorms at the College of Charleston. The surviving pedestrian stated that as they were crossing the street, they started to run as they were afraid of crosswalks. The investigating officer's report indicated that surviving pedestrian stated that she never saw the vehicle, but did see the headlights just before they were hit. The surviving pedestrian indicated that both she and the deceased were intoxicated. The toxicology report indicated the blood alcohol content of the deceased was 0.154%.

On January 13, 2014 at approximately 6:30 p.m., a motor vehicle heading northbound on Septima Clark Parkway at the intersection of Coming Street struck a pedestrian attempting to cross the intersection. According to the accident report, a jogger was running northbound parallel to Septima Clark to the intersection of Coming Street. The female jogger was running in place as she waited for the traffic signal to change to allow her to cross Septima Clark Parkway to go westbound on Coming Street. When the

According to the City of Charleston's Police Department, there were 109 accidents at the Coming Street/Septima Clark Parkway intersection between January 1, 2012 and October 14, 2014; four of the accidents involved pedestrians, as listed in **Table 3**. During the same span, there were 49 accidents at the Rutledge Avenue/Septima Clark Parkway intersection; none of the accidents involved pedestrians. **Figure 9** displays the location and date of the two fatal accidents at Septima Clark Parkway/Coming Street.

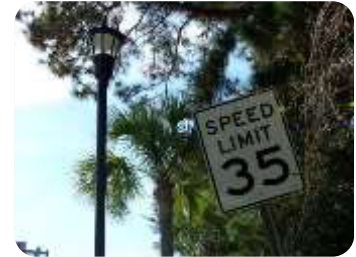
Charleston Police Department Traffic Divisions conducted a Traffic Speed Study at Septima Clark Parkway on Thursday January 23, 2014 for 30 minutes between 6:15 p.m. and 6:45 p.m. The results from the speed study found that almost 47 percent of drivers were traveling at or below the speed limit and approximately 14 percent of drivers were traveling at least 6 mph over the posted speed limit of 35 mph. Of the 148 vehicles observed, the average speed was 35.5 mph, as shown on **Figure 10**. The highest speed recorded was 45 mph and the lowest was 24 mph.

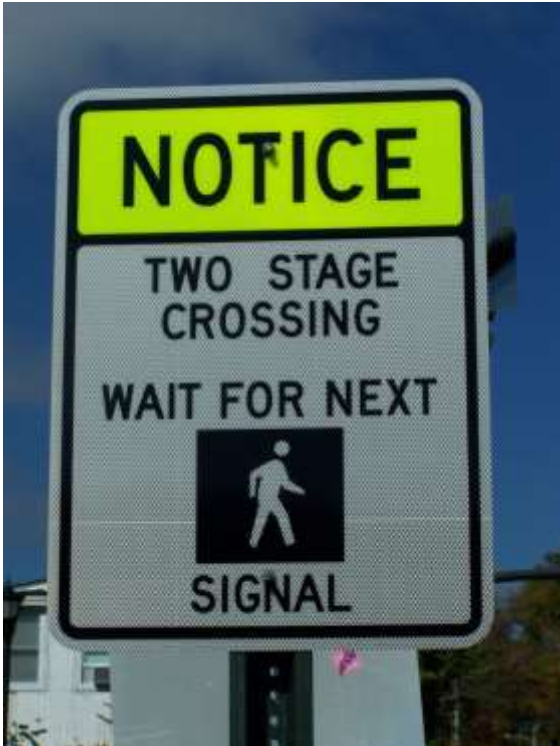
Figure 11 – R 10-2 Crossing Sign

**Figure 11** and **Figure 12** display the installed R 10-2 sign and two stage crossing sign respectively.

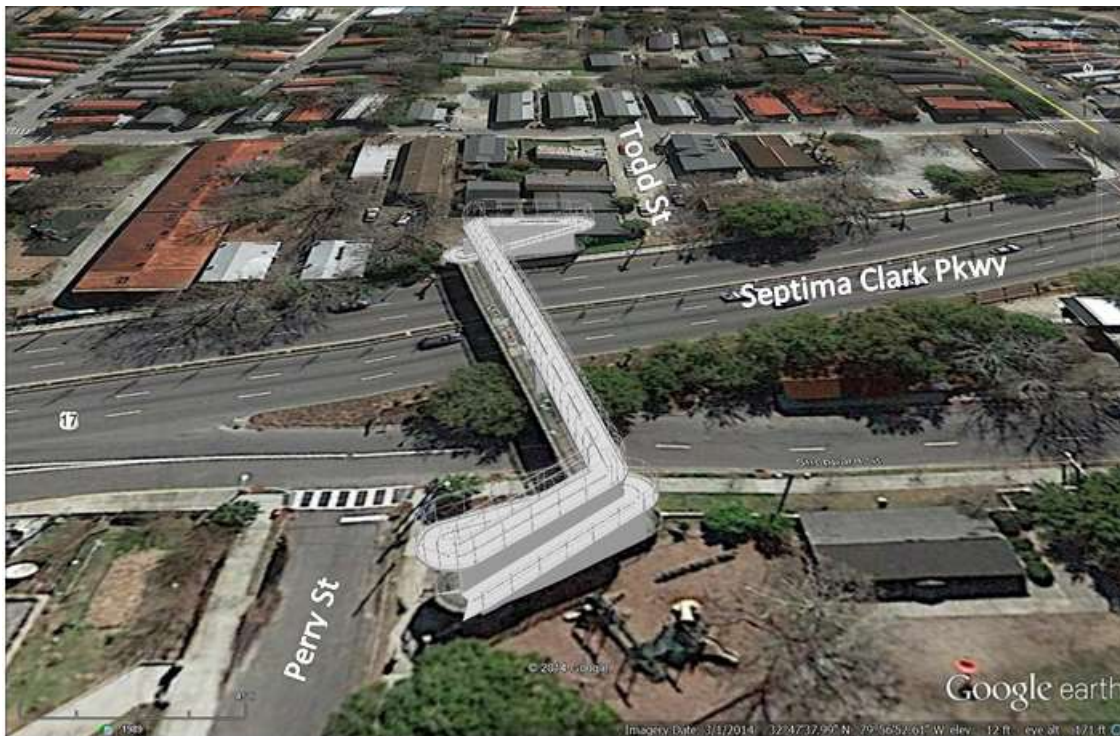
**Figure 13 – Existing Pedestrian Bridge**

The existing pedestrian bridge that spans Septima Clark Parkway was erected in 1975 to provide a safe connection across the highway. The bridge is located approximately 300 feet east of Rutledge Avenue and 850 feet west of Coming Street, as shown on **Figure 13**. The 170 feet long, 17 feet wide bridge crosses Septima Clark Parkway and Sheppard Street and has a vertical clearance of 17 feet 4 inches. The northern and southern bridge entrances are located at Mitchell Playground and Todd Street, respectively, as shown on **Figures 14** and **15**. The northern entrance provides ramp access from the sidewalks on Perry Street, and the southern entrance provides ramp access from sidewalks on Todd Street. Direct access to the Todd Street entrance is restricted from Septima Clark Parkway by a fence that stretches the entire one quarter mile segment along the highway. Southern access to this entrance is provided by Line Street.

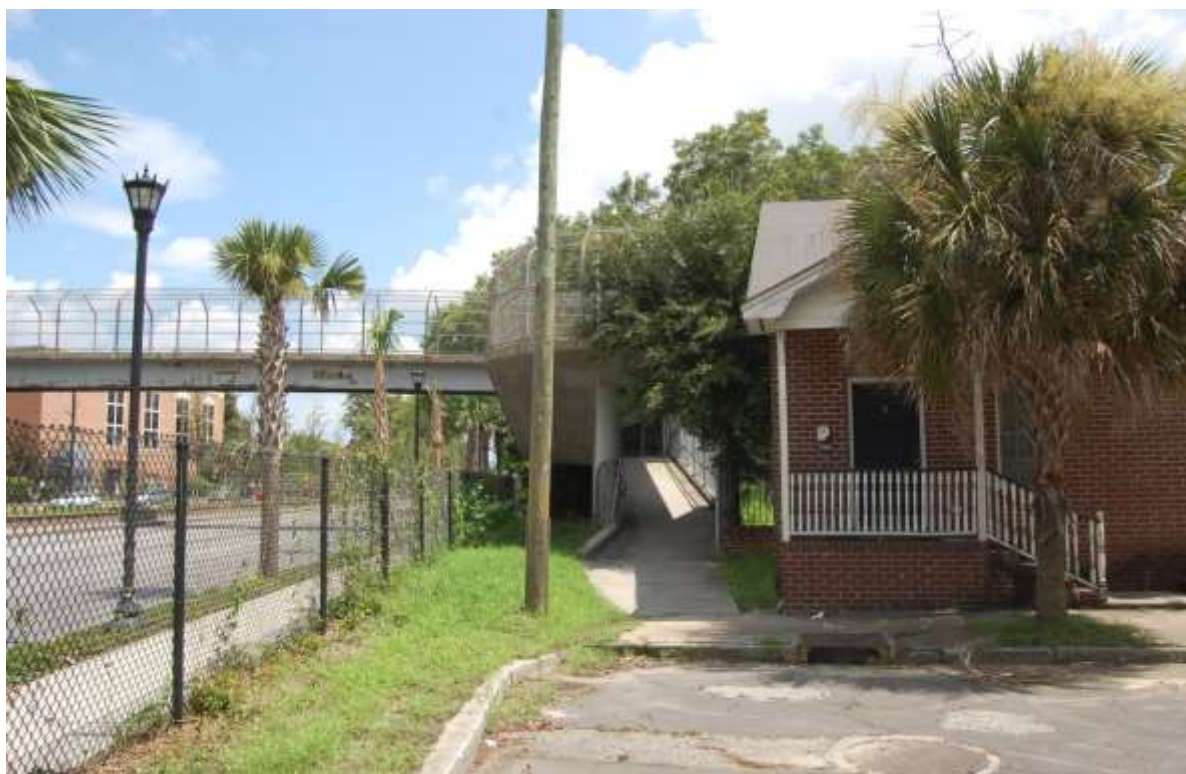
Figure 16 – Existing Pedestrian Bridge Crossing

**Figure 16** displays the existing pedestrian bridge and the approximate travel times. The distance and time to the pedestrian bridge from at grade crossing location is a key determination of use, in addition to safety. To cross from Coming Street/Septima Clark Parkway and from Rutledge Avenue/Septima Clark Parkway intersections using the existing bridge it takes approximately 12.1 minutes and 6.5 minutes respectively. The crossing times in this study were determined by using a moderate pedestrian walking speed of 3.5 feet per second. These travel times indicate using the pedestrian bridge may be undesirable and a number of pedestrians may elect to cross at grade.

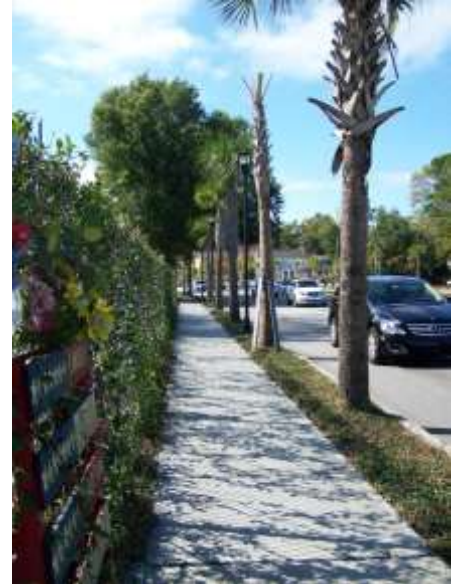
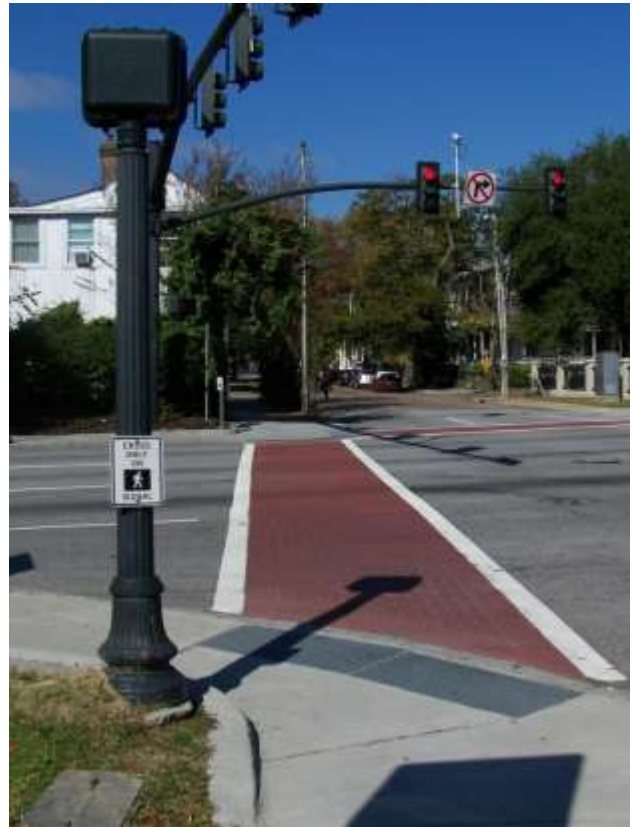
Figure 17 – At Grade Pedestrian Crossing Time

Currently, Septima Clark Parkway at grade pedestrian crossings within the study area is provided at the Coming Street/Septima Clark Parkway and at Septima Clark Parkway/ Rutledge Avenue intersection. As shown on **Figure 17** and in **Table 9**, at grade crossing times and travel times at Coming Street/Septima Clark Parkway and at Rutledge Avenue/Septima Clark Parkway are approximately 2.1 minutes and 1.6 minutes respectively. The total at grade crossing times includes the walking time and a maximum one minute delay at the pedestrian crossing signal. It takes approximately 10.1 minutes for pedestrians to walk between Coming Street/Septima Clark Parkway and Rutledge Avenue/Septima Clark Parkway using the at grade pedestrian crossings. It is approximately 5.6 minutes between Coming Street and Rutledge Avenue using the at grade sidewalk along eastbound

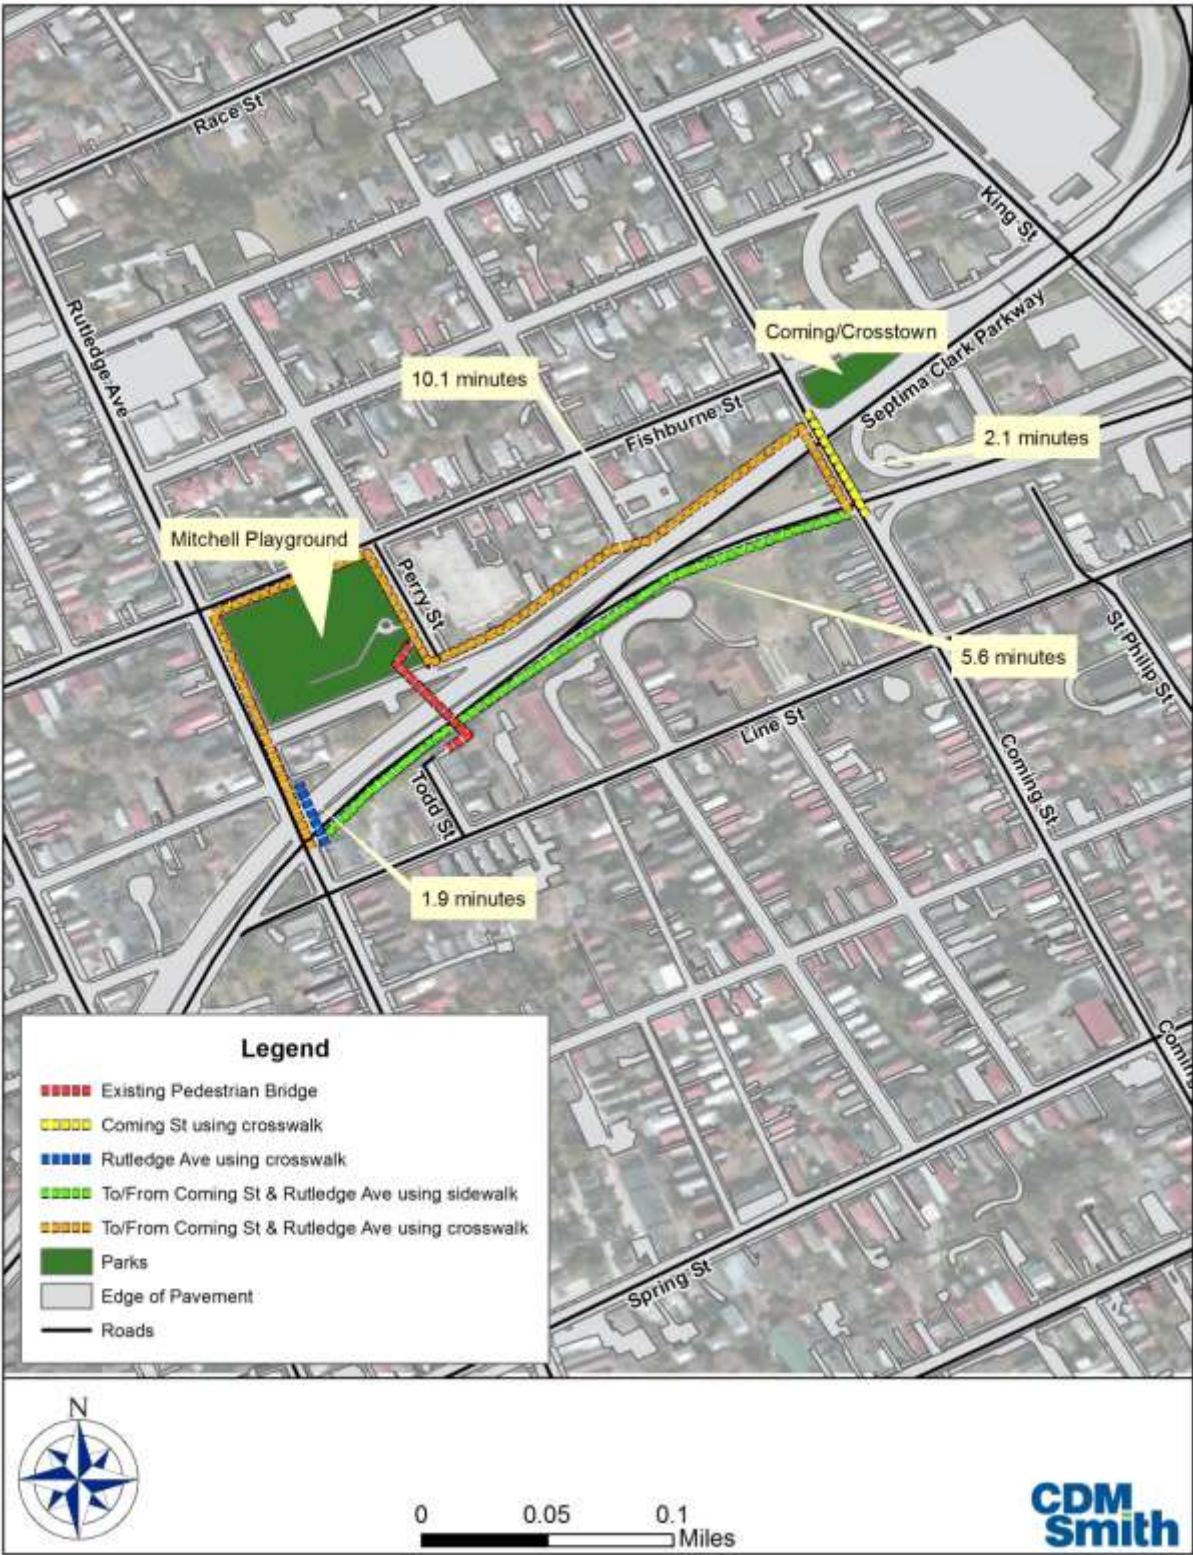
Intersection	Total Crossing Distance (ft.)	Travel Time	Existing Signal Timing
Rutledge Avenue/Septima Clark Parkway	125	1.6 minutes	25 seconds
Coming Street/Septima Clark Parkway	225	2.1 minutes	36 seconds (18 seconds for each stage)
Between Coming Street/Septima Clark Parkway and Rutledge Avenue/Septima Clark Parkway (using sidewalk)	1,180	5.6	
Between Coming Street/Septima Clark Parkway and Rutledge Avenue/Septima Clark Parkway (using crosswalk)	1,700	10.1

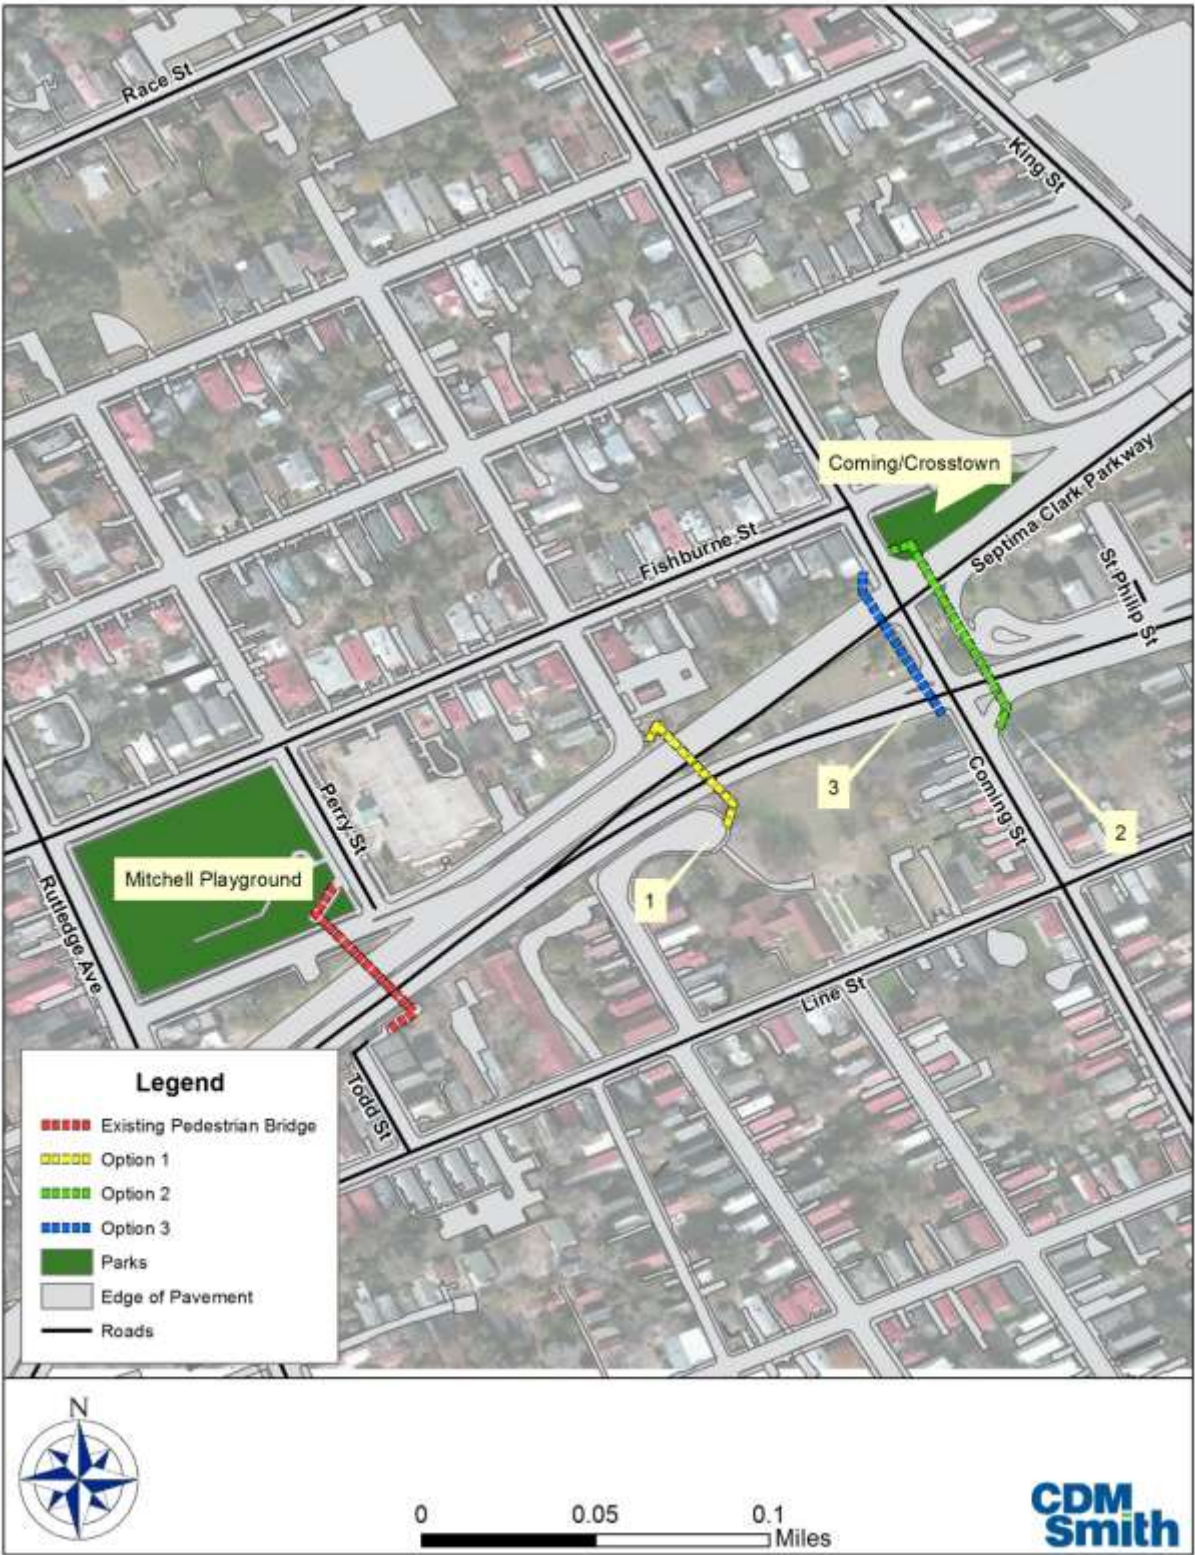
Figure 18 – Pedestrian Bridge Option

Advantages	Concerns
<ul style="list-style-type: none"> <li>• Direct access at Coming Street/Septima Clark Parkway crossing</li> <li>• Eliminate the need to make at grade pedestrian crossing at Septima Clark Parkway/Coming Street</li> <li>• Access points can connect to existing sidewalk</li> </ul>	<ul style="list-style-type: none"> <li>• Long bridge span</li> <li>• May be a visual obstruction for traffic on Septima Clark Parkway</li> <li>• Existing utilities and need relocating</li> <li>• Signal mast arm on north leg is located near proposed location</li> <li>• May require property acquisition</li> <li>• Bridge would not adequately service pedestrians from Rutledge Avenue</li> <li>• Pedestrians may still use at grade crossing for convenience and shorter crossing time</li> </ul>

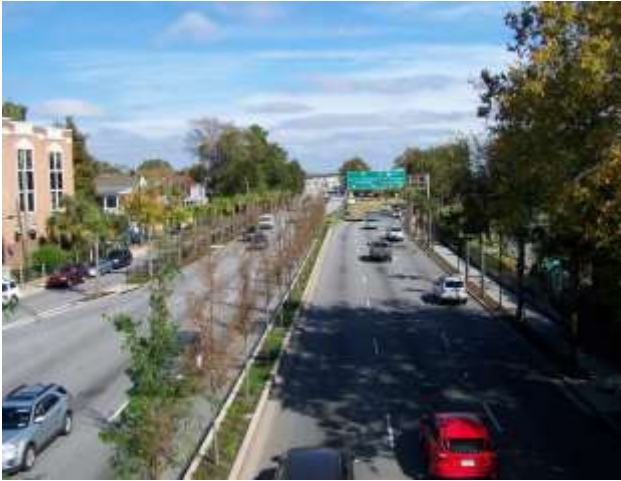
Figure 19 – Coming Street from Existing Bridge

Option 1 provides an access point to the south at the Ashe Avenue circle and a north access point at Sheppard Street/South Tracy Street. This option would be located east of the existing overhead sign for I-26/US-17. **Figure 19** displays a view of eastbound Septima Clark Parkway from the existing pedestrian bridge. The property east of Ashe Avenue is utilized by Calvary Church and already has sidewalks which can provide ramp access. Sheppard Street/South Tracy Street have existing sidewalks that can provide access to the bridge ramp. This option would be similar to the existing bridge in crossing length. **Table 11** lists the advantages and concerns of Option 1.

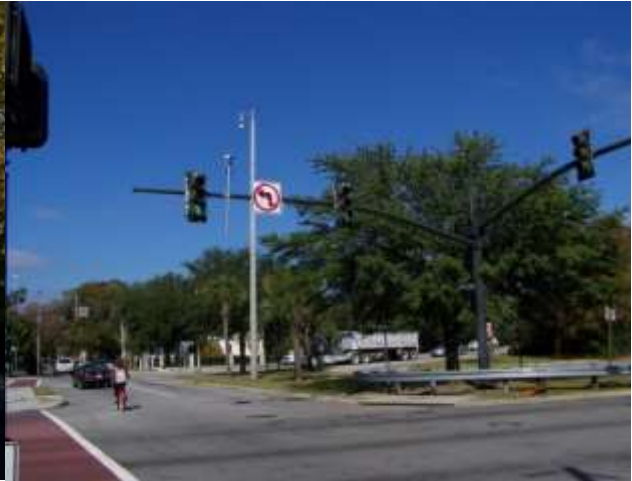
Figure 20 – East Leg of Septima Clark Parkway/ Coming Street

Option 2 is located at the east leg of Coming Street/Septima Clark Parkway intersection. This option crosses over westbound Septima Clark Parkway exit to King Street. **Table 12** lists the advantages and concerns of Option 2. **Figure 20** displays the east leg of Coming Street/Septima Clark Parkway intersection at the location of proposed Option 2.

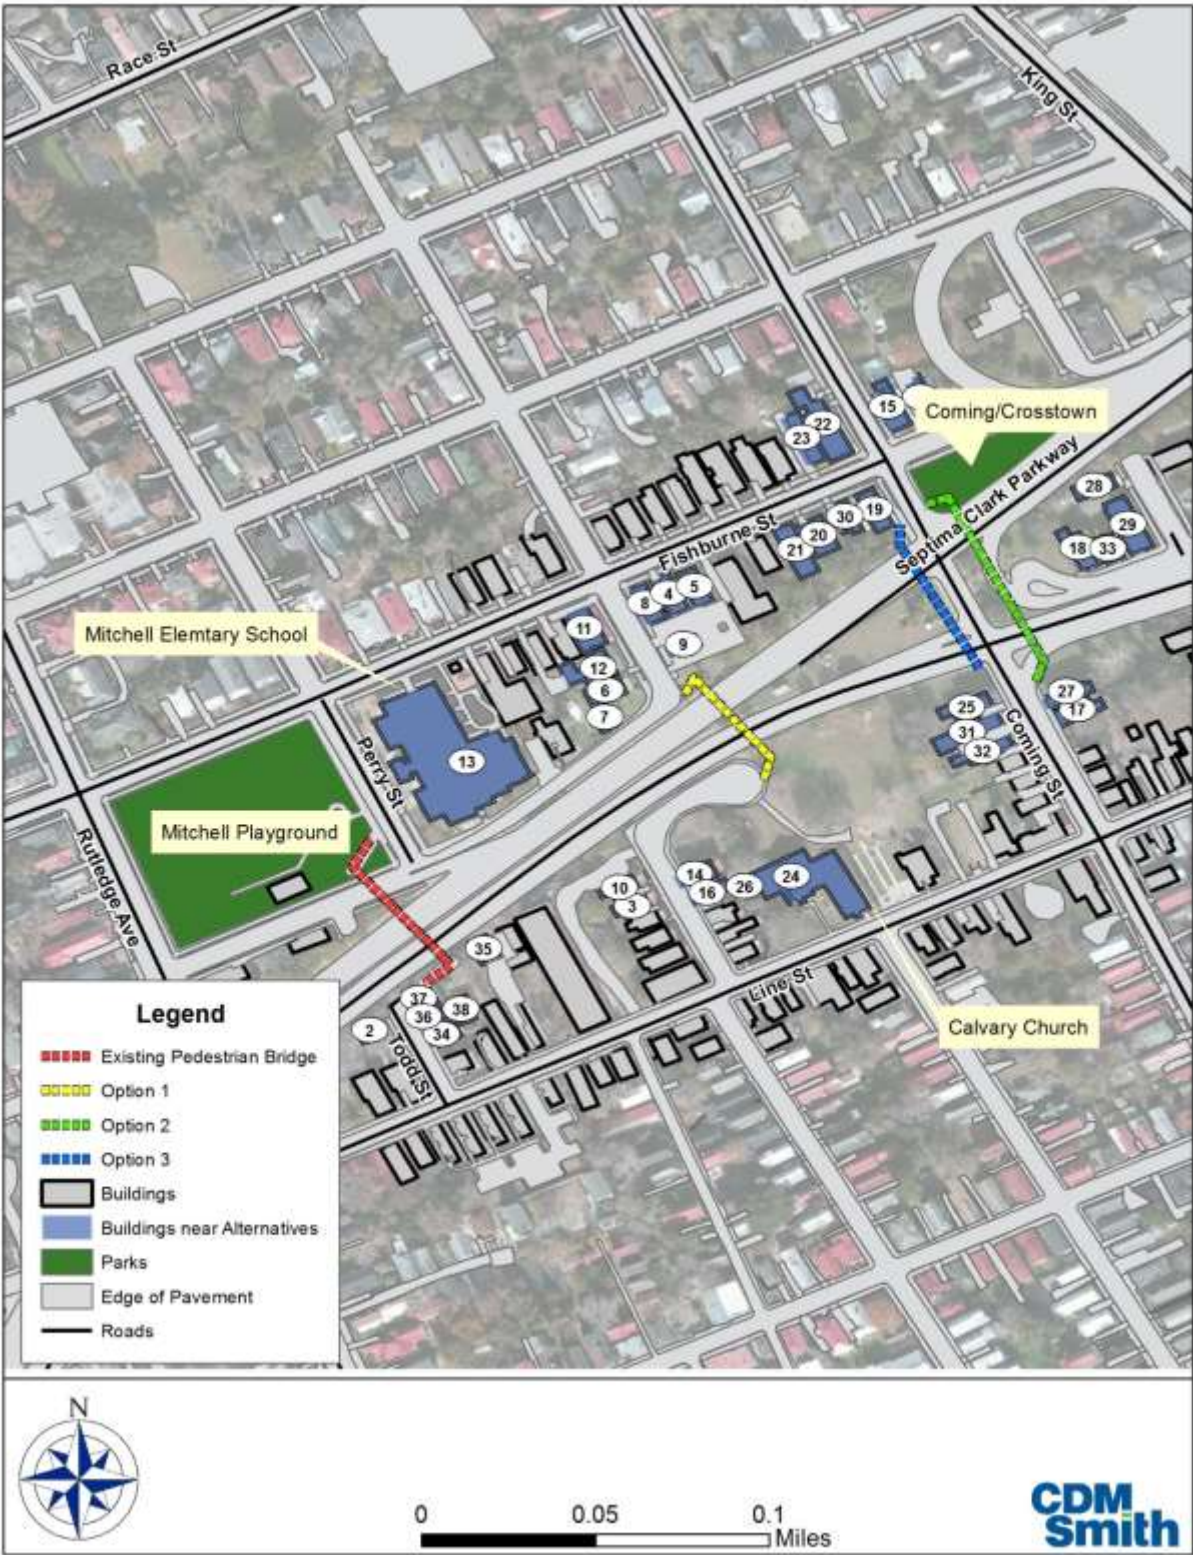
Figure 21 – Existing Buildings Near Alternatives

The land use around the area of the existing pedestrian bridge and the bridge options are primarily residential with light mix use including schools, and small businesses. **Figure 21** displays the properties and buildings near the study area. Additional parcel information can be found in **Appendix B**.<sup>6</sup> A detailed analysis of land use and zoning is appropriate if any proposed action would result in a significant change in land use or would substantially affect regulations or policies governing land use. Notable properties near the study area include Mitchell Elementary School, which is located in the proximity of the existing pedestrian bridge, and Calvary Church which is in the close proximity of Option 1.

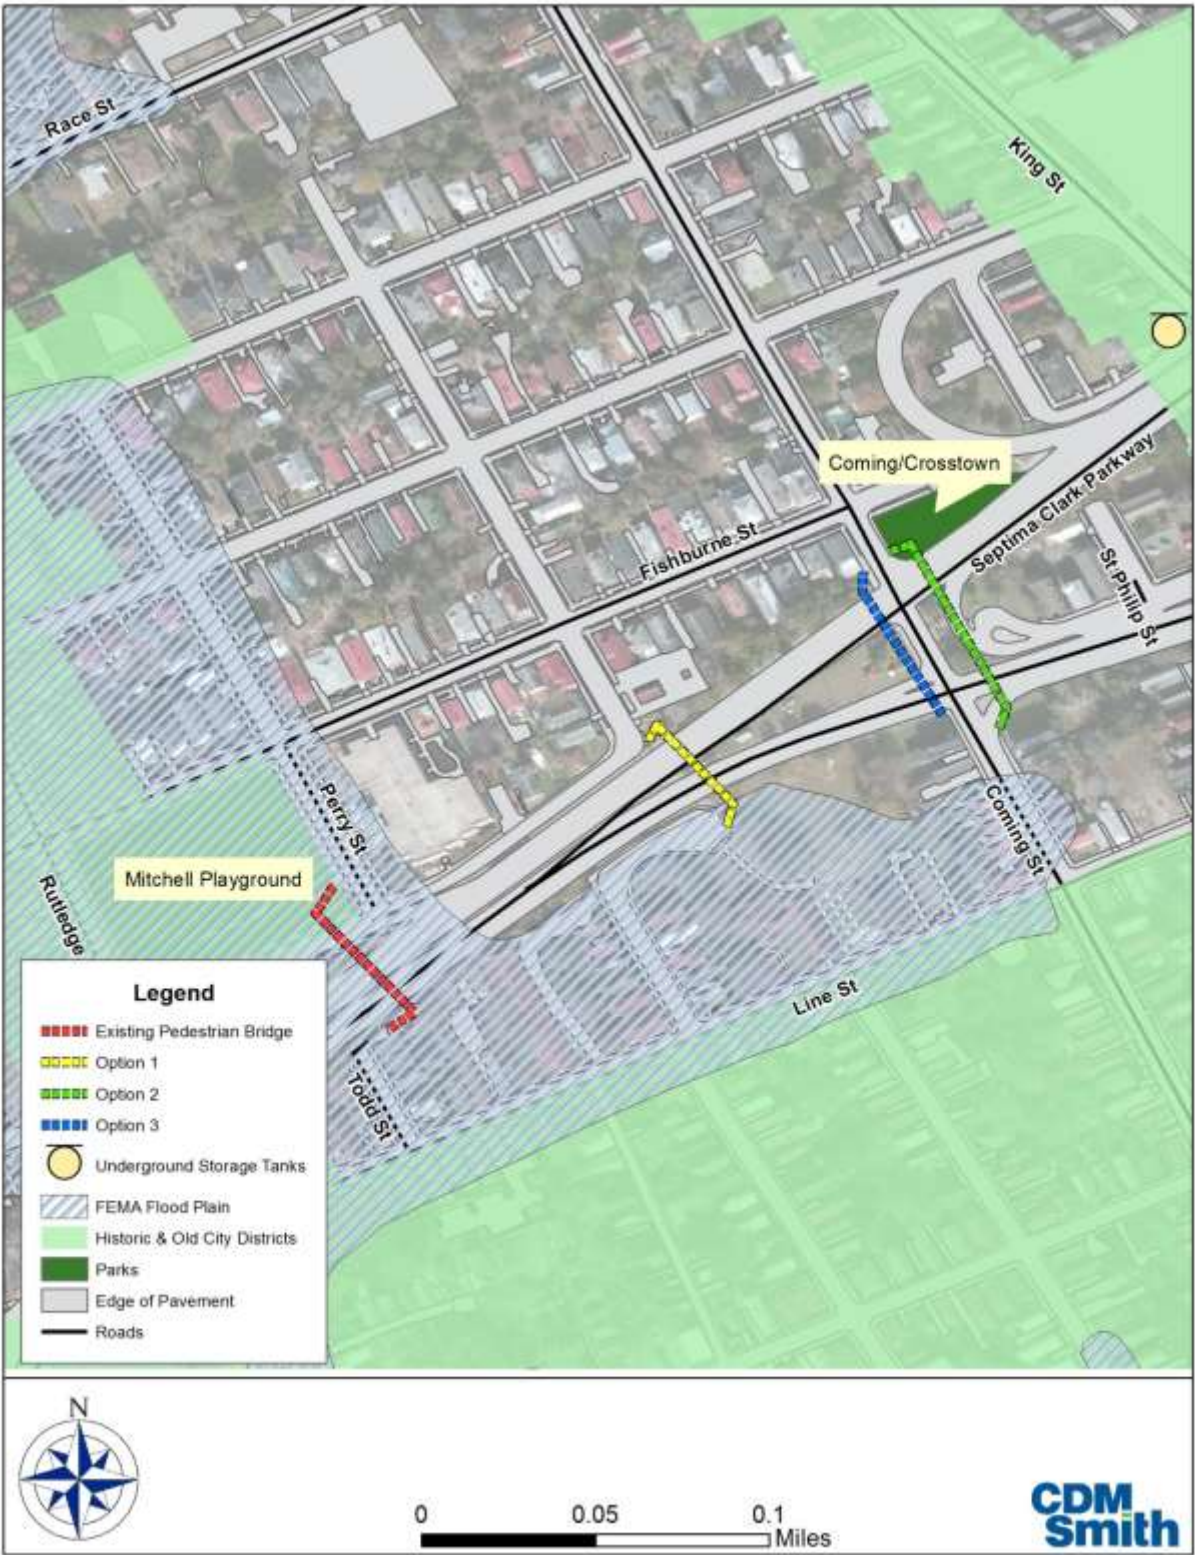
Figure 22 – Environmental Considerations

**Figure 22** displays environmental considerations including the surrounding locations which are classified as historic property, floodplains, underground storage tanks, in the study area. Mitchell Playground and the north access of the existing pedestrian bridge are located within historic property, while none of the three proposed Options will affect property that is classified as historic.

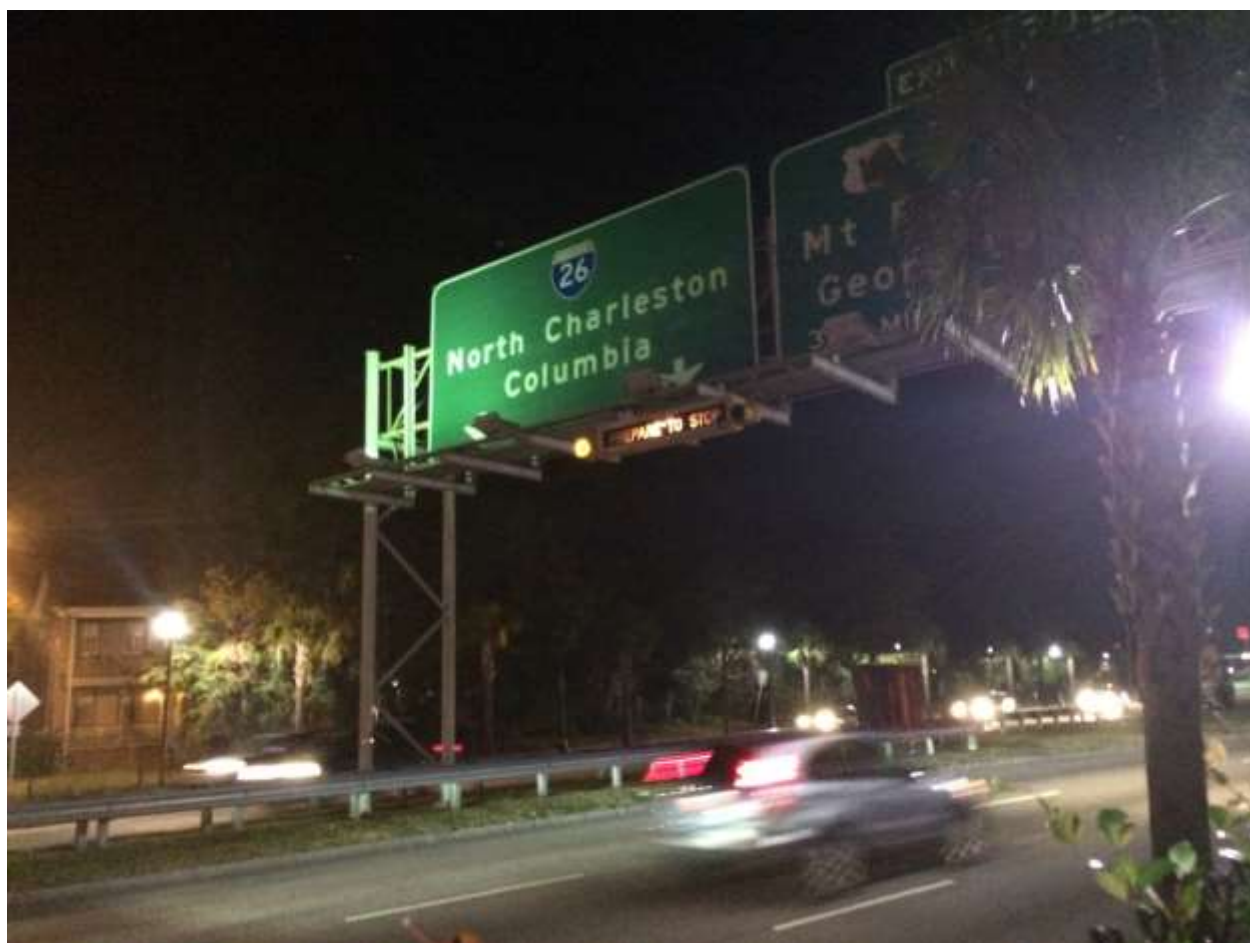
Figure 27 – Overhead “Prepare to Stop” Sign

**Figure 27** displays an existing traffic calming sign on eastbound Septima Clark Parkway. The overhead "Prepare to Stop" traffic signal sign is a visual cue to slow driver's speed approaching the intersection of Septima Clark Parkway/Coming Street. As shown in the figure, during night conditions, the sign has low visibility. It is recommended that the sign be upgraded or replaced to increase visibility and to improve driver awareness of the intersection ahead.

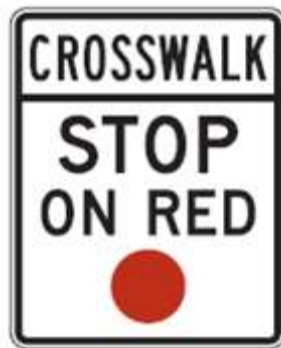
Figure 29 – R10-23 “Crosswalk, Stop on Red” Traffic Signal Sign

As shown in **Figure 28** and **Figure 29** the R10-23 "Crosswalk, Stop on Red" sign is used for additional emphasis to alert drivers to stop before the crosswalk and allow pedestrians to cross the roadway safely. As stated by the MUTCD, the R10-23 "Crosswalk, Stop on Red" sign is only to be used in conjunction with actuated pedestrian hybrid beacons that are coordinated with a signalized intersection.<sup>13</sup> **Figure 30** displays examples and phasing sequence for pedestrian hybrid beacons.

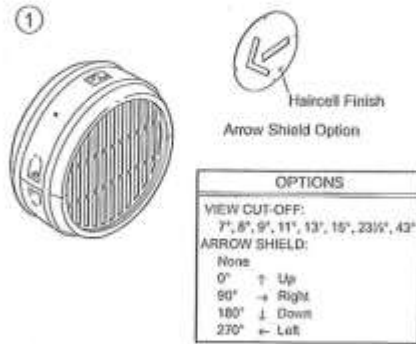
## SIGNAL ACCESSORIES Geometrically Programmed Louver

ITEM	DESCRIPTION	PART NO.
①	GPL, Geometrically Programmed Louver, 12" w/o Visor .....	GL-1001
②	GPL, Geometrically Programmed Louver, 12" w/ Visor .....	GL-1010
③	INSTALLATION KIT, w/o Screw Gun, Includes visor marking template & sleeve, sizer/plier pen, adjustment tool, 1/4" & 5/16" shock cord assys. & small tool box .....	GL-2001
④	INSTALLATION KIT, w/ Screw Gun, Includes visor marking template & sleeve, sizer/plier pen, adjustment tool, 1/4" & 5/16" shock cord assys., cordless Makita screw gun w/ 5/16" magnetic socket, battery charger & large tool box .....	GL-2002
5	ADJUSTMENT TOOL, GPL w/ Depth Gauge .....	GL-1002
